Paul Pouvillon's Astronomical Clock
A Brief History and Description of the Clock's Restoration
By Mark Frank

A Brief History and a Description of the Clock's Restoration

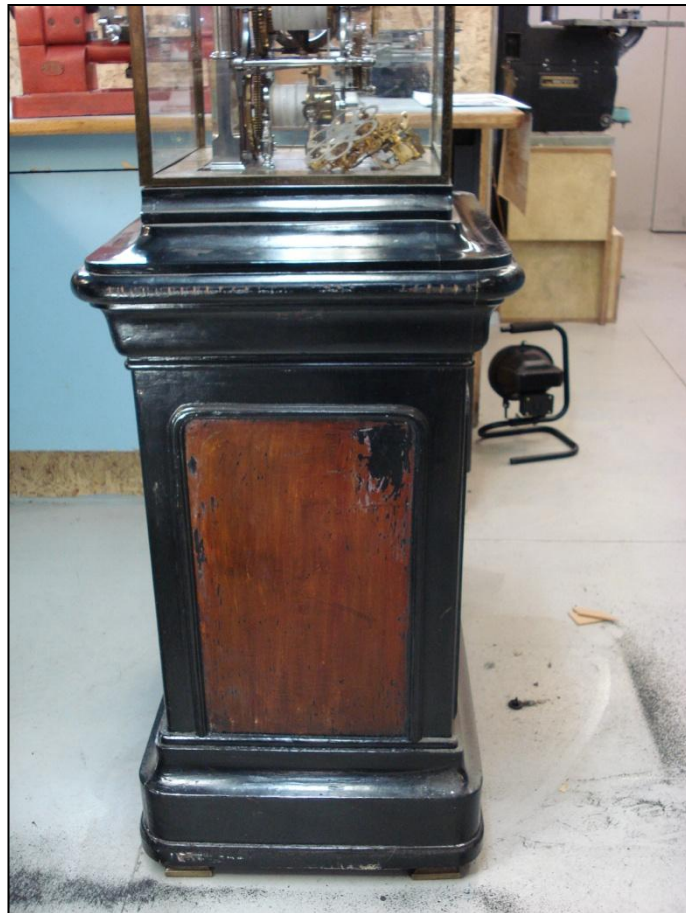
Figure 16. Initial removal of black spray paint overlay

Figure 15 shows evidence that the wood base did not originally have a black, painted finish. In fact, upon close inspection the black finish was a spray painted coating on the underlying wood finish. The spray painted finish seemed to be fairly easy to scrape off without causing too much damage to the underlying surface, (Figure 16).

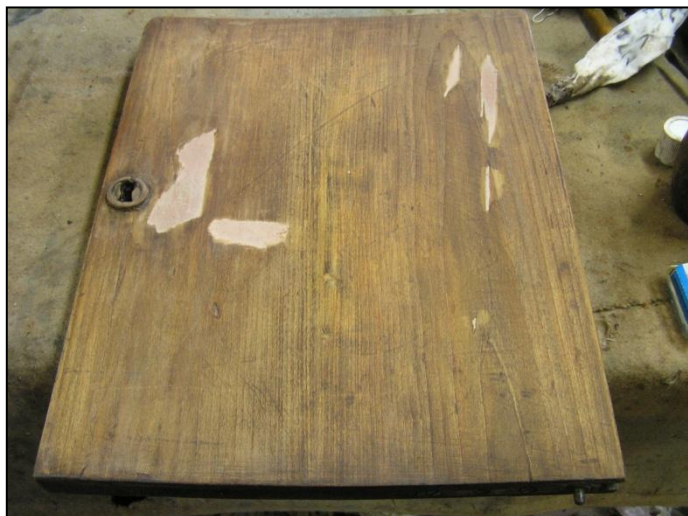
Figure 17. Wood filler hiding damages to the access door

The first evidence of damage, one of many areas which ultimately lead to the cabinet being painted, was located in the base access door. After the paint was removed we found several very deep gouges were hidden by filler before being painted, (Figures 17, 18).

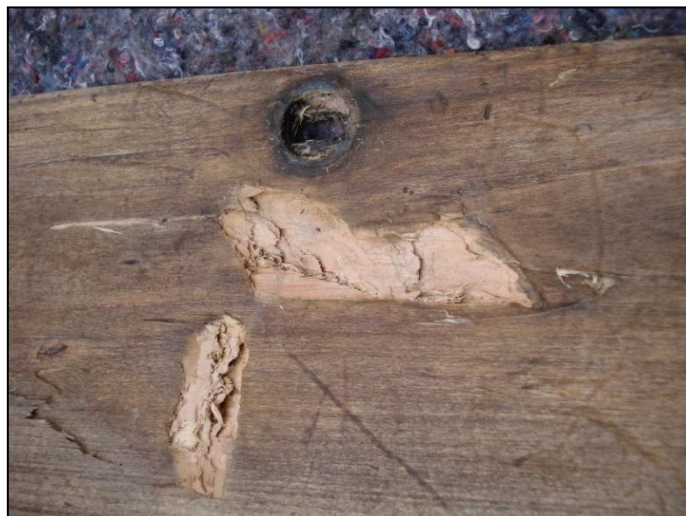
Figure 18. Deep gouges revealed after wood filler is removed

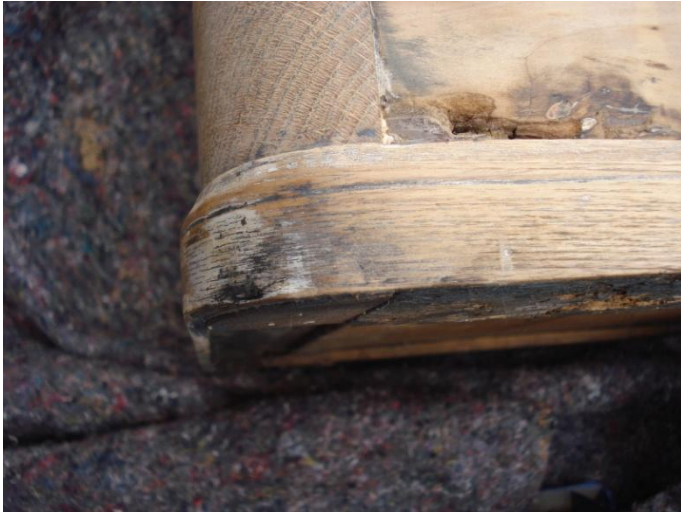
Figure 19. Example of damage to base of pedestal

Figure 19 shows another gouged out area near the base. Figure 20 depicts an area where wood was extensively replaced with later joined wood on an area of the upper decorative surround molding to the base of the upper seat board.

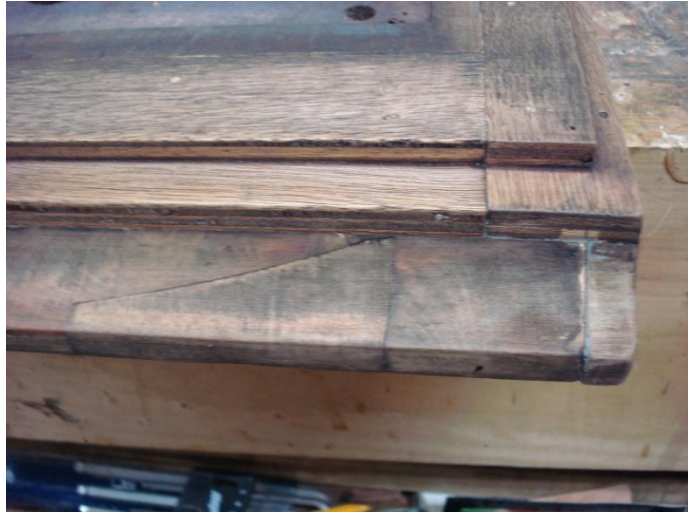
Figure 20. Replaced wood to surround of upper seat board

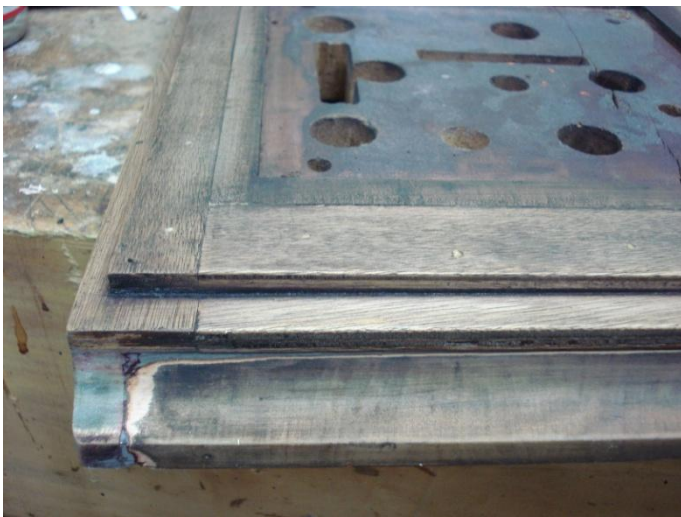
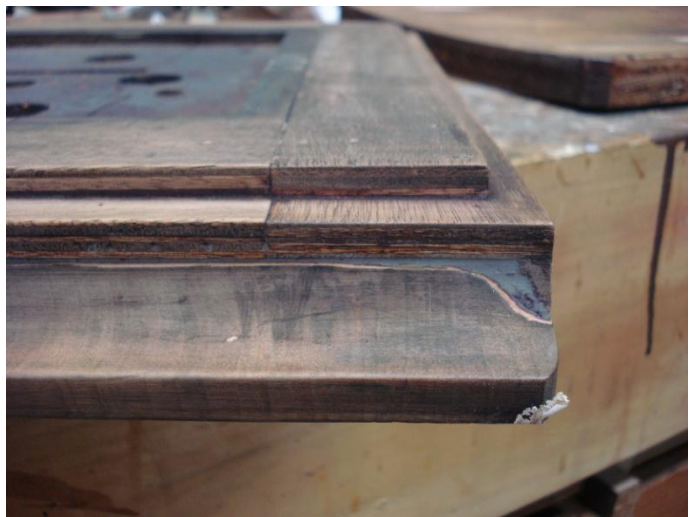
Figure 21. Wood filler hiding defective areas prior to paint

Figure 22. Wood filler hiding defective areas prior to paint

Figures 21 and 22, further illustrate areas with wood filler. These were put in prior to the black paint finish.

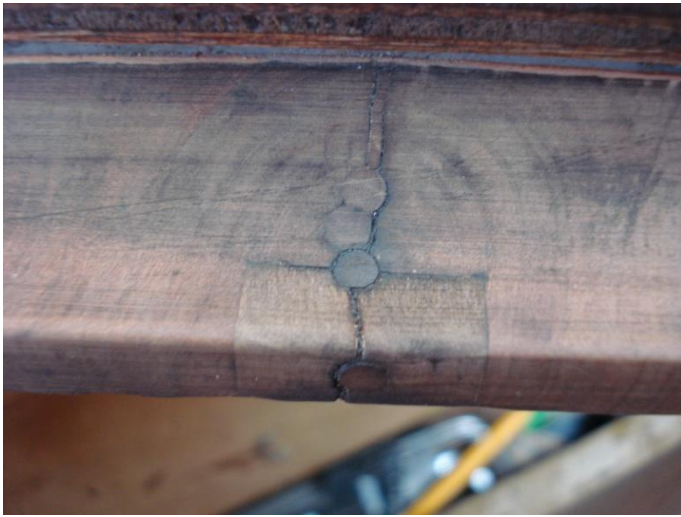
Figure 23. Curiously repaired area using dowel and blocks

Figure 23 shows a curiously repaired area where apparently wood doweling as well as a wood block was used to repair a broken section. In the next photo we see another wood filler area.

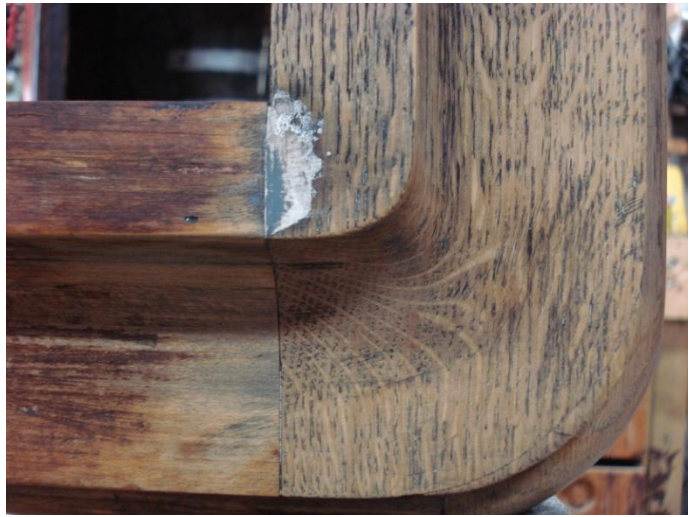
Figure 24. Additional wood filler area.

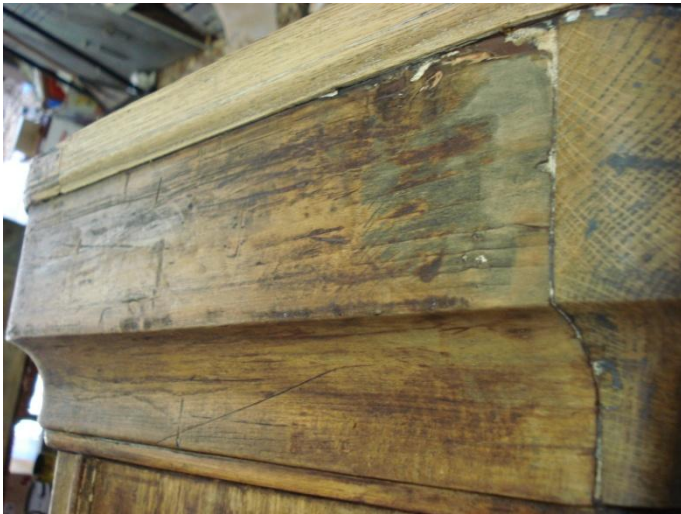
Figure 25. More evidence of gouging and scratching

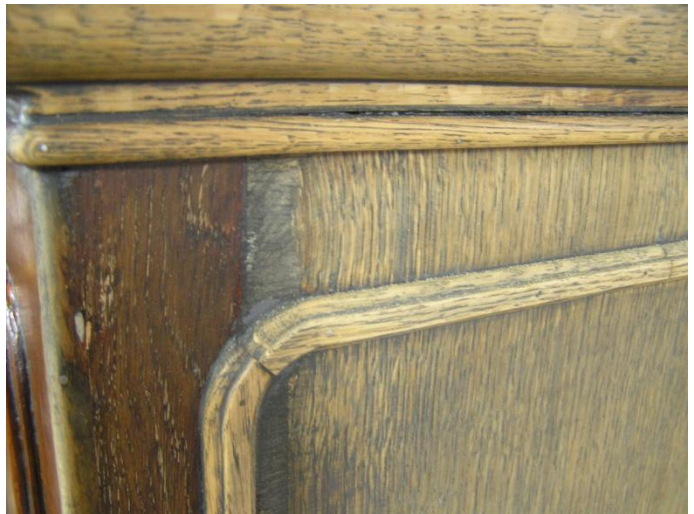
Figure 26. Different shading between wood sections

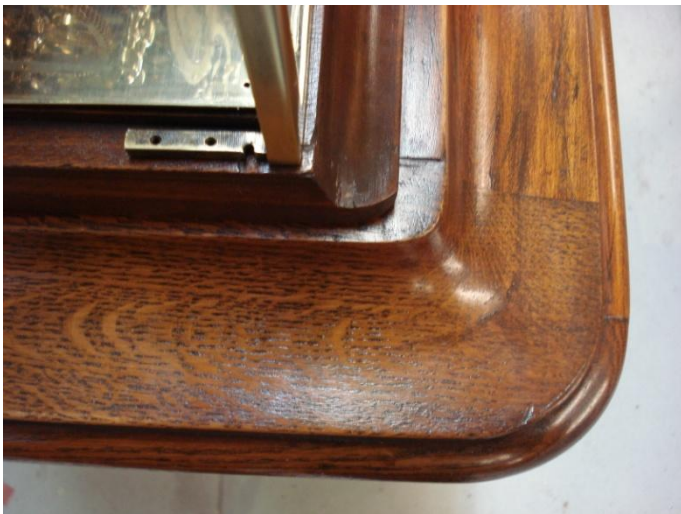
Figure 27. Restored finish

Again a judgment call was needed. The base, as designed by Pouvillon had a wood grained finish. From what was exposed, I could see that if it could be brought back to that state, even with the flaws, that it would be far more attractive than the later black finish. So in summary B was chosen. Following are photos of the restored base.

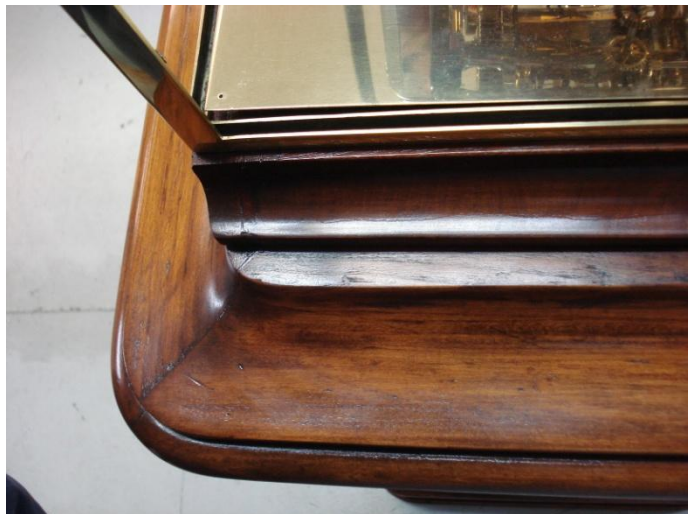
Figure 28. Restored finish

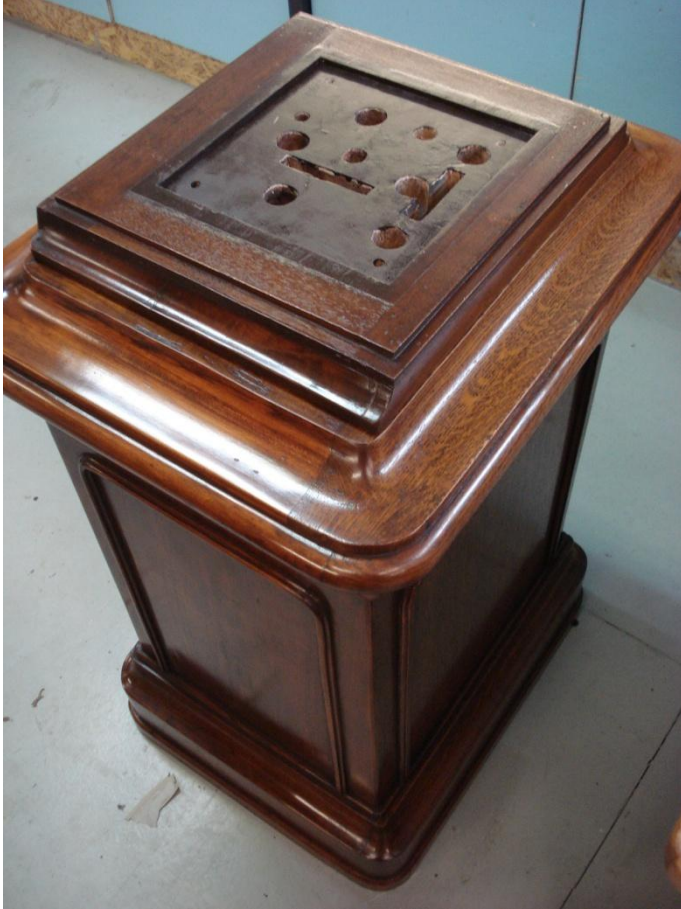
Figure 29. An overview of the refinished base

The seat board one sees on the top is the upper seat board upon which the clock is attached, (Figure 29, 30). Figures 31, 32, display the skill of the cabinet maker to hide the flaws inherent in the original repaired case. The access door rails were carefully stretched back to conform back to a flat profile, (Figure 33). Compare this to the way the door was originally warped, (Figure 13, page 53). The center panel had suffered too much damage to be salvageable and a new carcass of plywood was used to prevent any future warping and to this plywood was then applied an oak veneer with a matching grain on both sides. This is how one gets a mirrored graining on both sides of the door to give it the look of a panel made from a single, solid material, (Figure 30, 34). The interior of the case was left untouched aside from a cleaning.

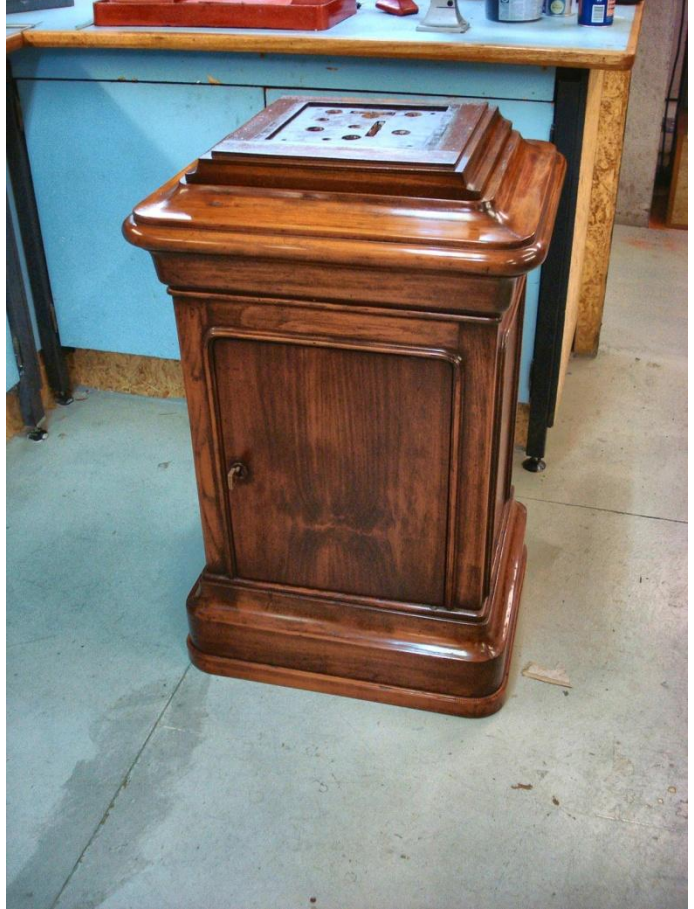
Figure. 30. An overview of the refinished base.

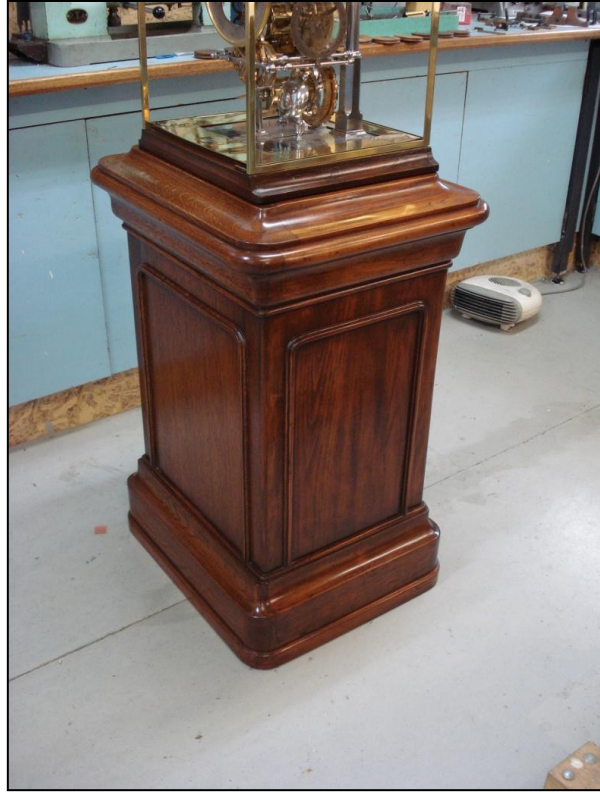
Figure 32. Same view as in figure 31

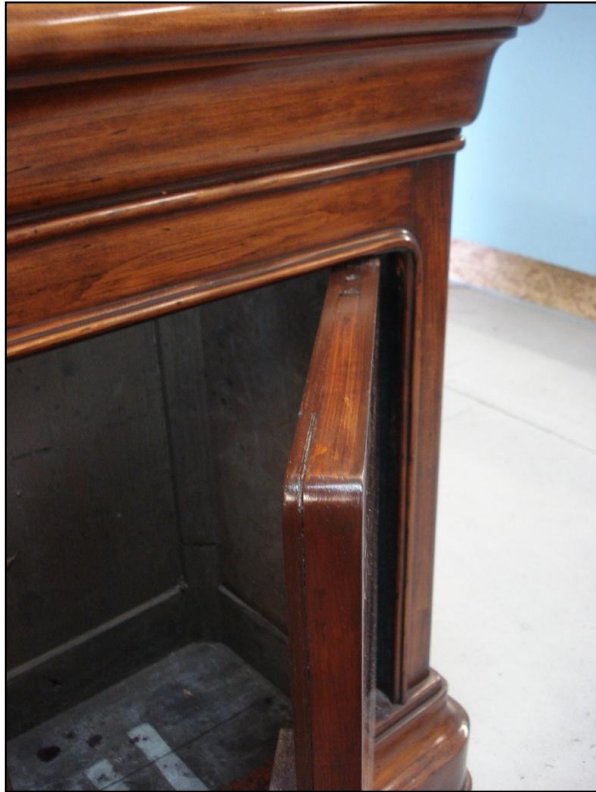
Figure 33. Warped door now straightened

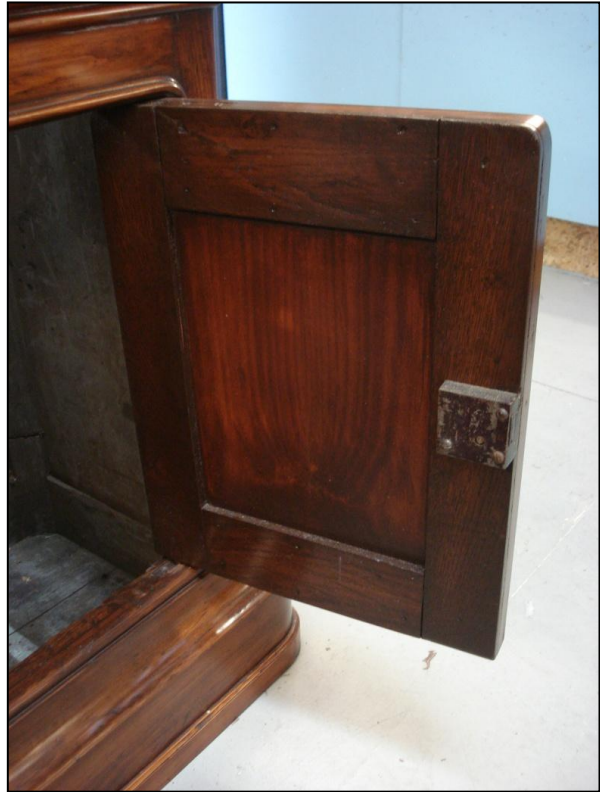
Figure 34. Veneered inside center panel of door
